# Service Bulletin

| <b>Subject:</b><br><br>SHIFT SHOCK | <b>Bulletin No:</b> 05-004/12 |
| | <b>Last Issued:</b> 11/01/2012 |

2012-2013 Mazda3 (SKYACTIV-G and A/T) with VINs lower than JM1BL\*\*\*\*\*702072 (produced before July 25, 2012)

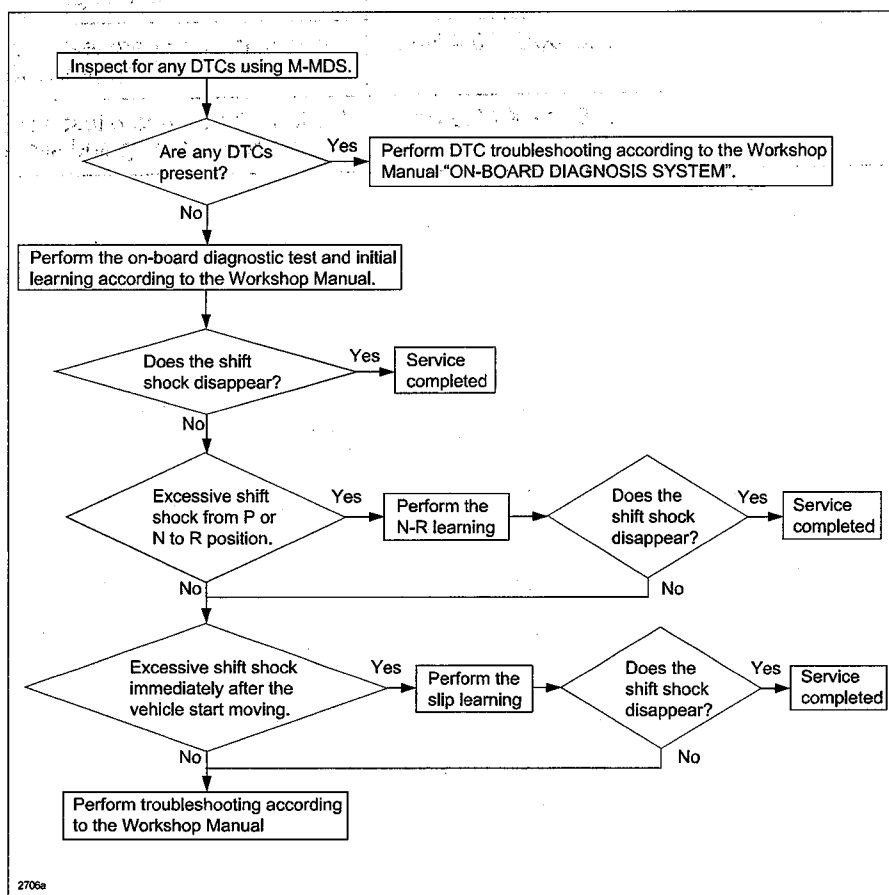
### Diagnosis Flowchart

Some vehicles may experience an excessive shift shock at one or more of the following conditions:

- When shifting from P to R position or N to R position.
- When the transmission shifts immediately after starting to move (in D position).
- When the transmission shifts at cruising speed (in D position).

The initial learning may not have been completed at the time of vehicle production. To correct the problem, one or more learning procedures may need to be performed.

1. Verify customer concern.
2. Follow the Diagnosis Flowchart on the following page and perform the N-R and/or Slip Learning Procedure.
3. Verify repair.

1. Verify the ATF temperature reached 60°C (140°F) or over.
2. Shift the selector lever from N to R position and wait for 5 seconds
3. Shift the selector lever from R to N position and wait for 5 seconds
4. Repeat steps 2 to 3 ten times.

1. Verify the ATF temperature reached 20°C (68°F) or over (\*1).
2. Drive the vehicle until upshifting from 1st to 2nd gear occurs at each of the following accelerator pedal position (APP) percentages: 20%, 40%, 60%. Monitor the APP PID using M-MDS and come to a complete stop before moving to the next one.
